Stone Matrix Asphalt (SMA) case study,  
Thornton, Illinois  
Analysis of 20-year Stone Matrix Asphalt  
Material on Williams Street

*1<sup>st</sup> International Conference on  
Stone Matrix Asphalt (SMA)  
Atlanta, Georgia  
November 6<sup>th</sup>. 2018*

*Abdul Z. Dahhan, P.E.  
Chicago Testing Laboratory, Inc.  
Thornton-Warrenville - Joliet, Illinois*

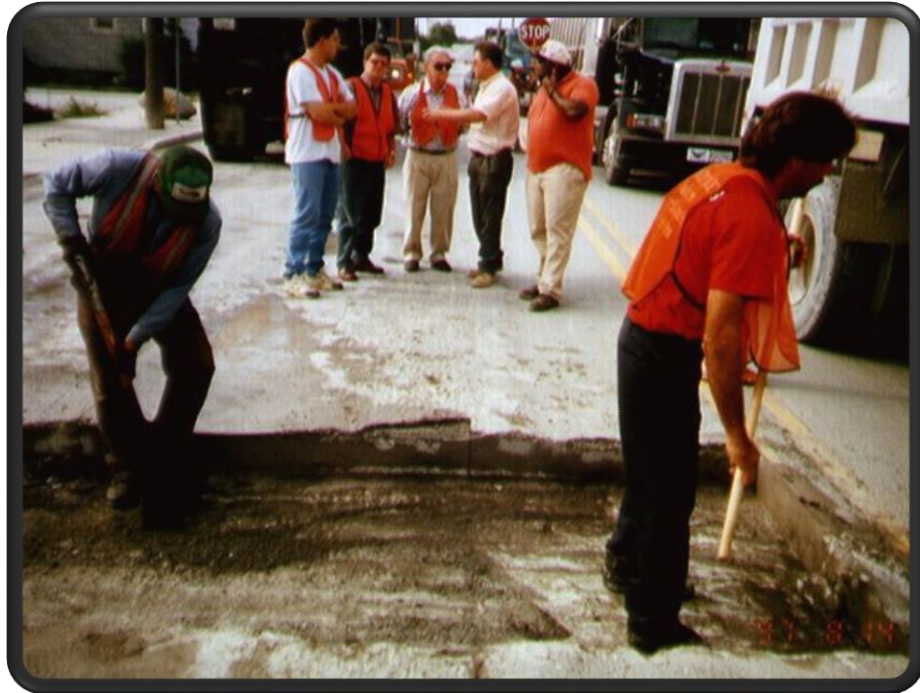
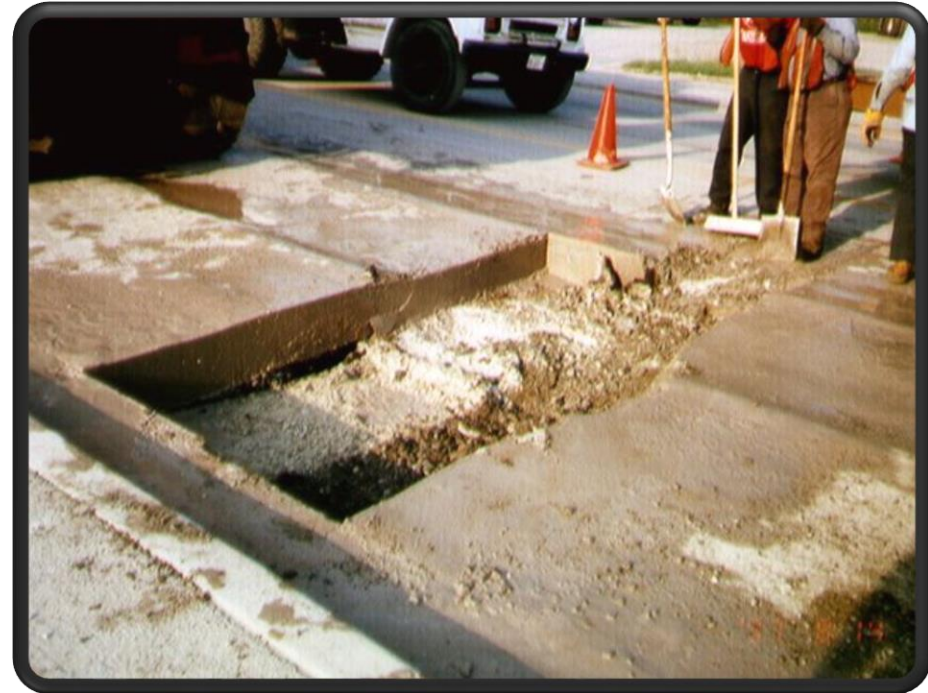
Analysis of lifted slabs indicated significant deformation extending to approx. 9 inches deep into the pavement.

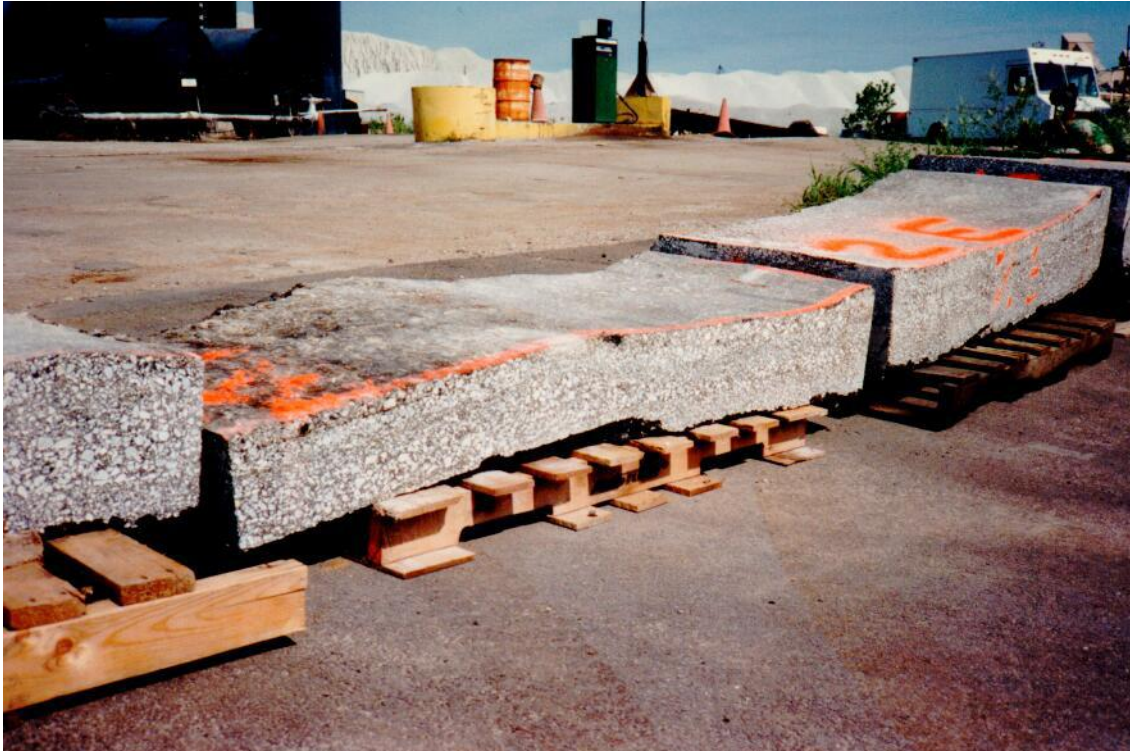
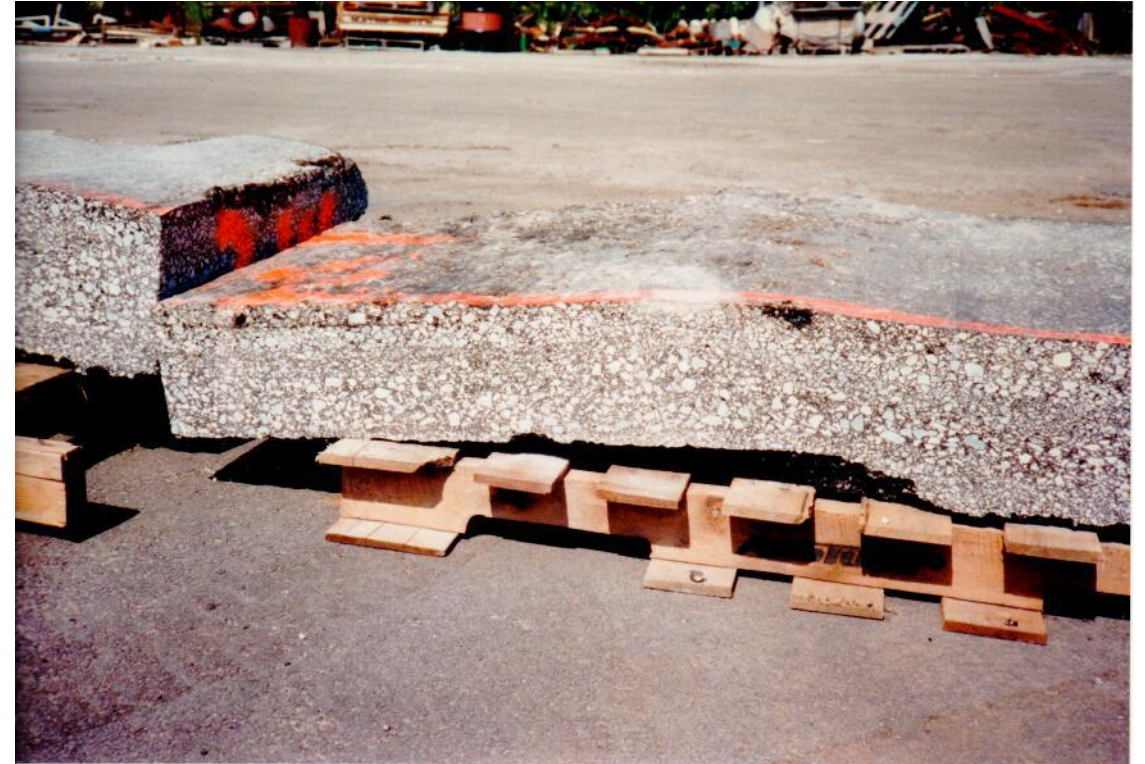
## Full Depth HMA Pavement: 1997

How the Pavement in the North Bound Lanes looked back then!

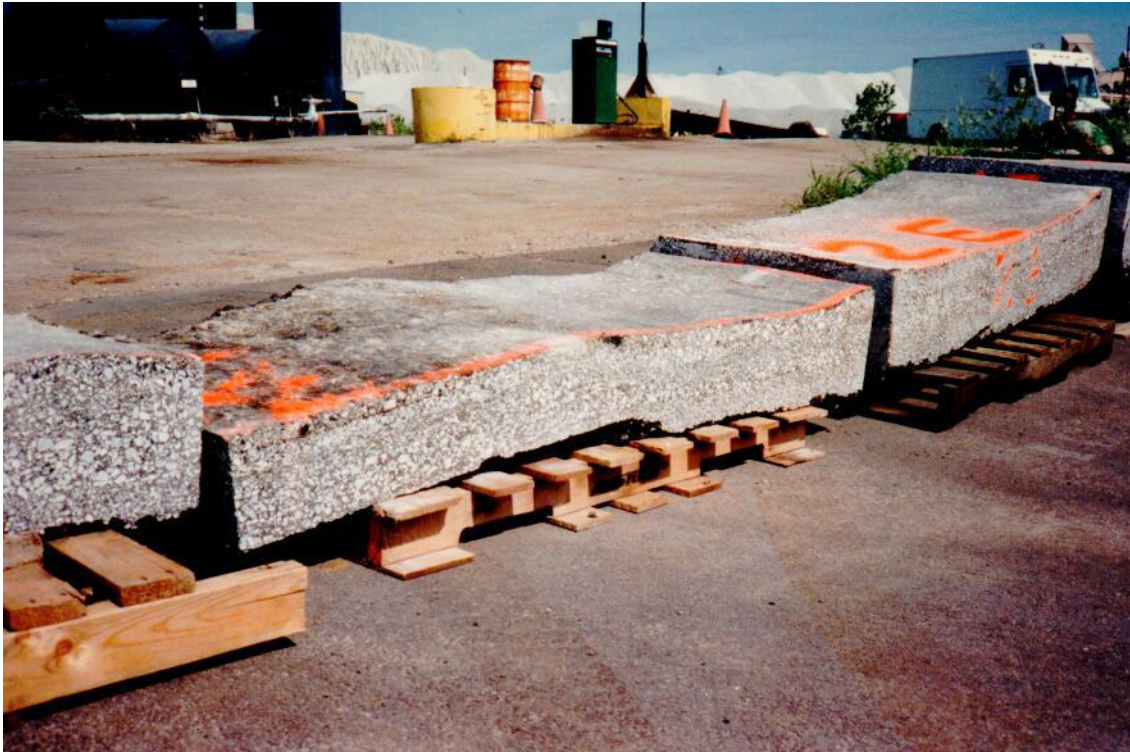
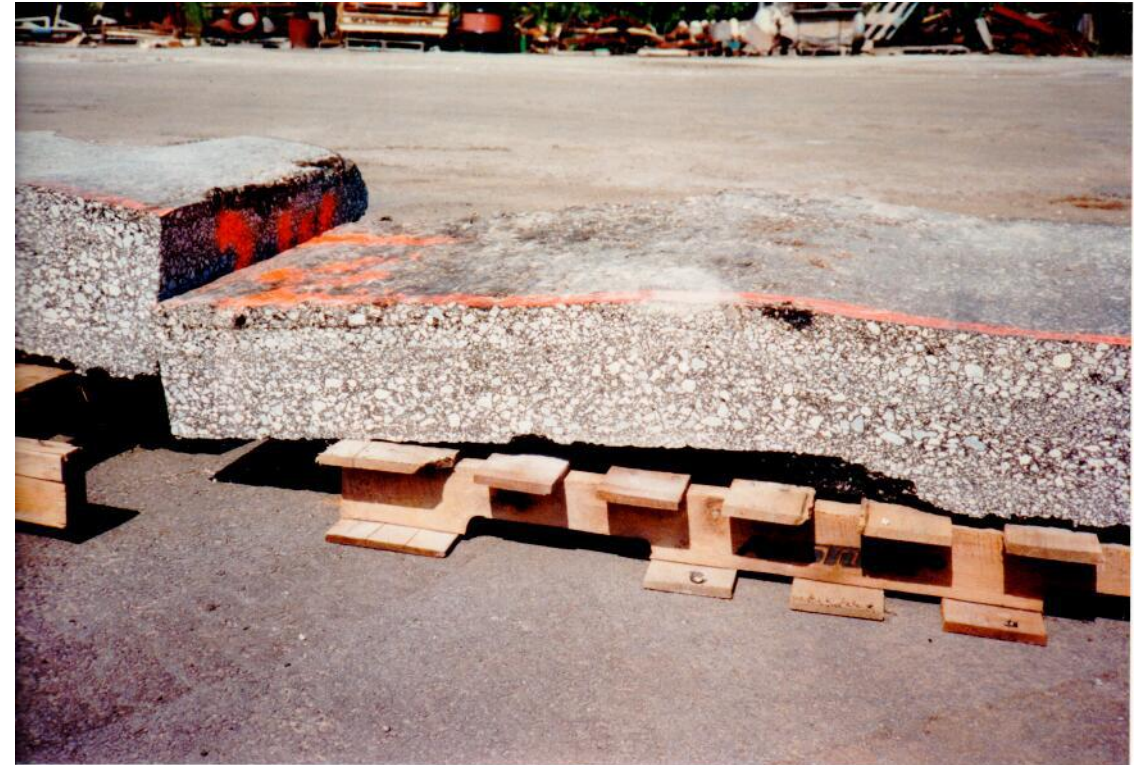
Three lifts were of dolomitic aggregate SMA, and the additional top lift was 2" comprised of a steel slag aggregate as the wearing surface.

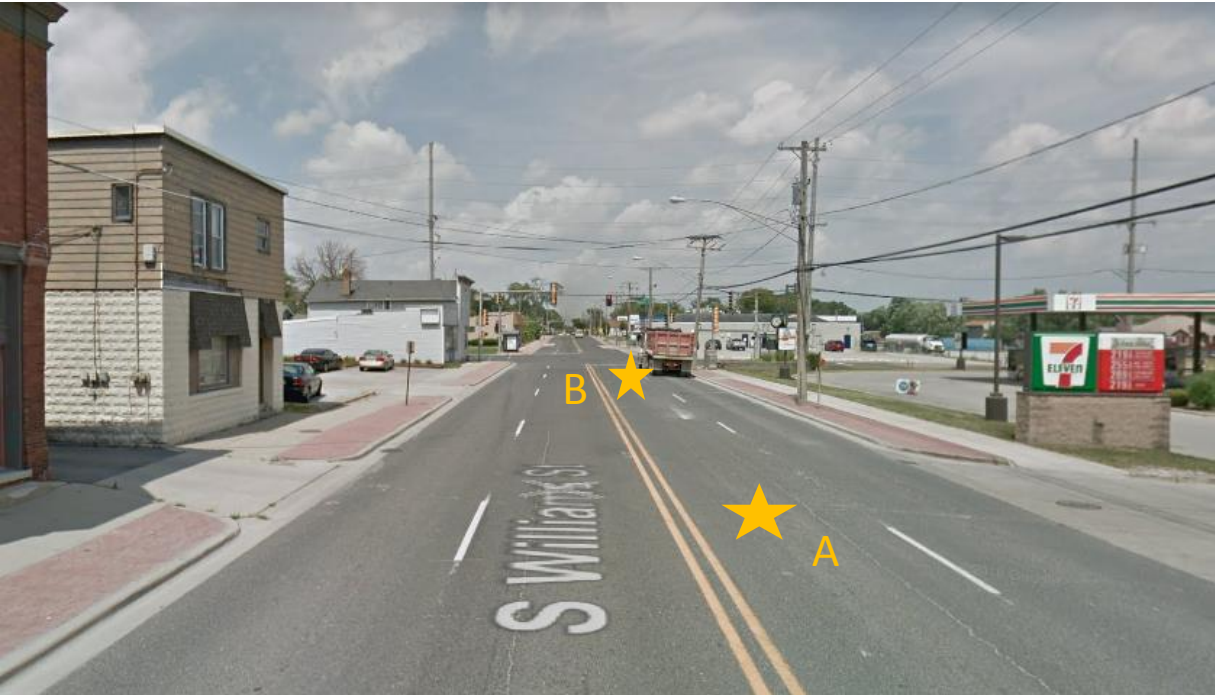
# Location of coring areas in the Fall of 2017

CTL ID	Location Details
A	6-inch cores 100 feet from Williams St. and Margaret St. stop line. No significant visual rutting.
B	6-inch cores 50 feet from Williams St. and Margaret St. stop line. Some visual rutting identified.
S-1	Surface lift of 4-inch cores taken from Williams St.
B-1	Binder lift of 4-inch cores taken from Williams St.

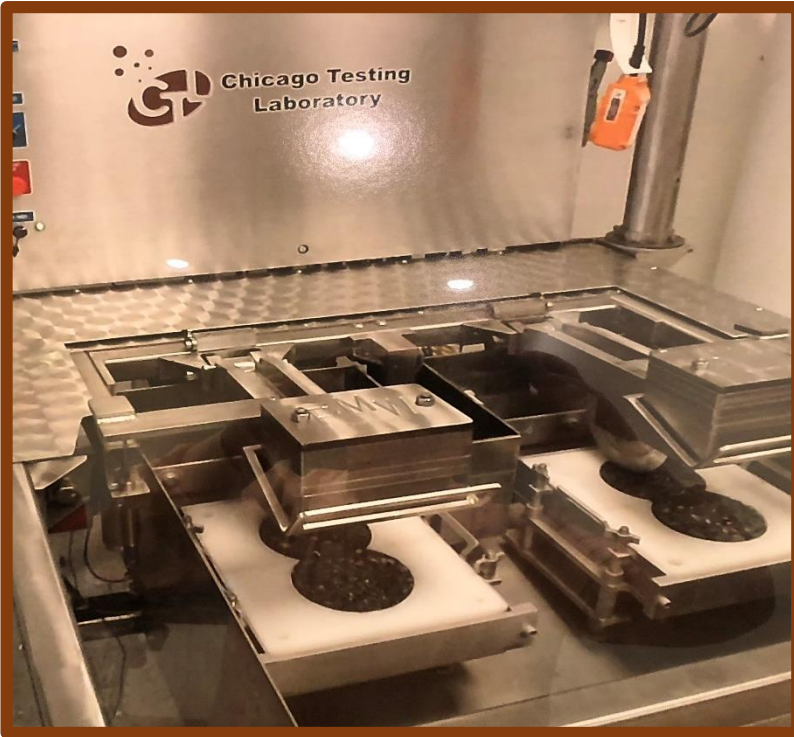
# Summary of performance test results

CTL ID	Flexibility Index	Rut Depth at 10,000 Cycles	Rut Depth at 20,000 Cycles
A Surface Lift	4.4	1.76 mm	1.98 mm
A Binder Lift	12.1	1.45 mm	1.83 mm
B Surface Lift	4.6	2.50 mm	2.85 mm
B Binder Lift	18.5	1.95 mm	3.13 mm

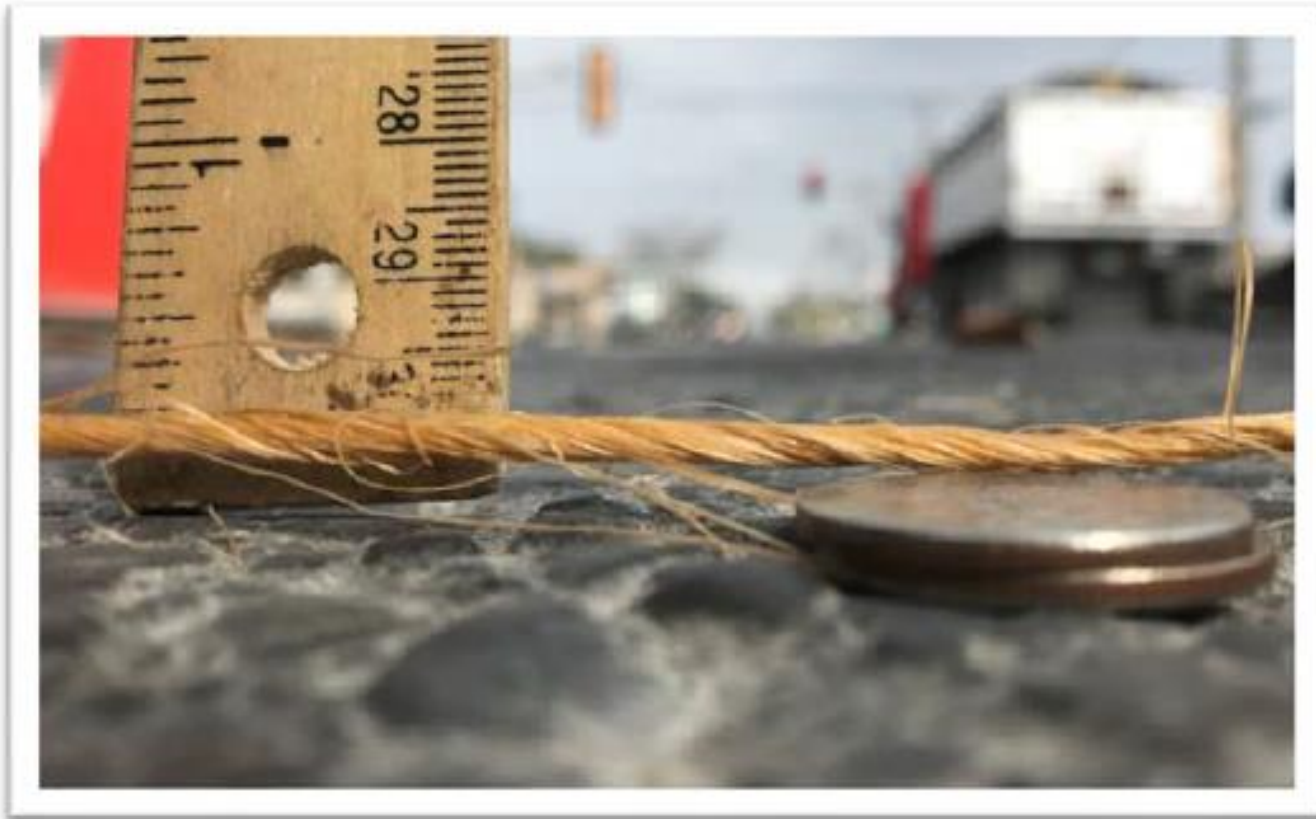
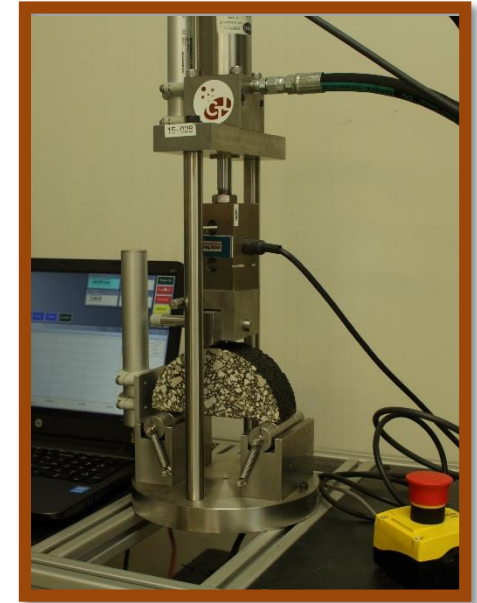
Rut Depth String Line, Williams St. Intersection

The Flexibility Index showed that the SMA Binder course provided a better flexibility index than the SMA Surface course.

Additional rutting during the Hamburg wheel analysis showed that the in-place mixture was not expected to have significant additional deformation.

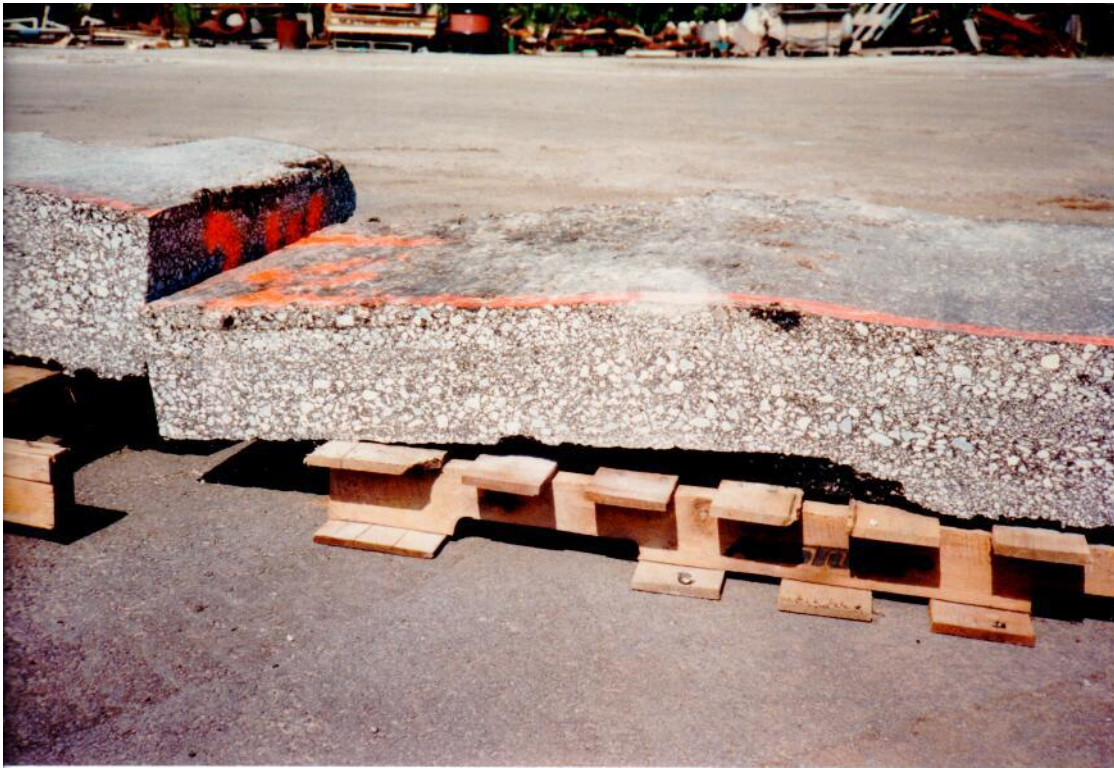
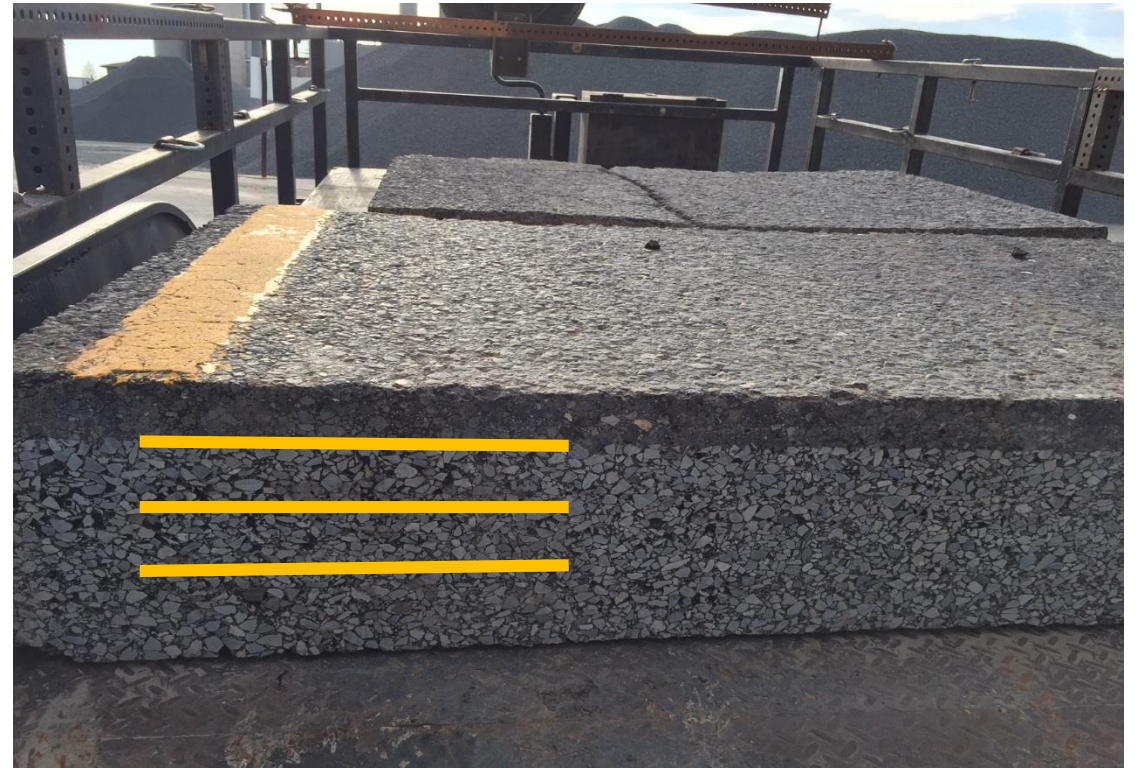
IDOT's decision to use full-depth SMA at the intersection has proven successful. The original SMA binder lifts, will remain in place as a perpetual pavement intersection, now with a new polymer 4.75 mm leveling course and two inches of new surface SMA.

Use of SMA, including full-depth perpetual SMA, is recommended in any high loading condition pavement where long term rut resistance and durability are desired.
