# Stone Matrix Asphalt

### 2004

Results of 2004 Existing Condition Survey

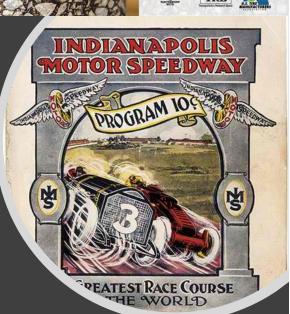
- 1936 Asphalt patches applied to portions of turns
- 1937 All <u>turns</u> completely paved with "Ky Rock"
- 1938 Short chutes paved
- 1939 Back stretch paved, but ~1900' of front stretch <u>still brick</u>

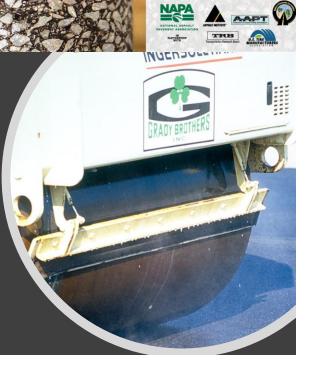
- 1955 All <u>existing</u> asphalt portions resurfaced with "Ky Rock"
- **1961** Remaining bricks covered on front stretch
- 1964 Back stretch and turn 3 resurfaced
- 1969 Front stretch and turns 1, 2 and 4 resurfaced

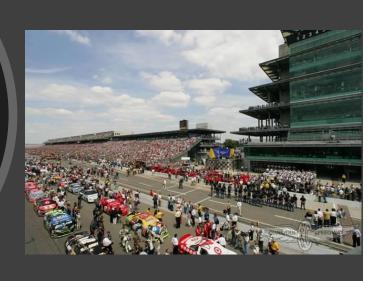
- 4<sup>th</sup> (CURRENT) Complete Resurfacing
- Main Oval, Pit Lanes and Warm-up Lanes
- SMA Utilized for Both Lifts
- Extensive Treatment of Longitudinal Joints

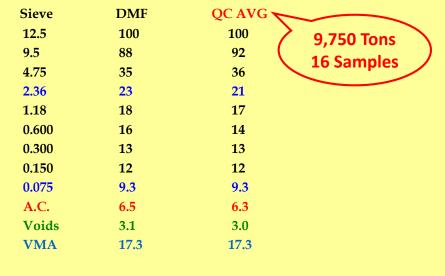
### 9.5mm *Dolomite* SMA

Avg. Core Density (N=34)

94.8% of G<sub>mm</sub>

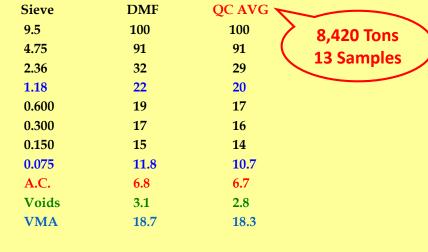
### 4.75mm Steel Slag SMA

Avg. Core Density (N=25)

94.3% of  $G_{mm}$
