# **NCHRP 9-49A Project Update: Performance of WMA Technologies: Stage II – Long-term Field Performance**

**Binder ETG Meeting  
Oklahoma City, OK  
Sept 15, 2015**

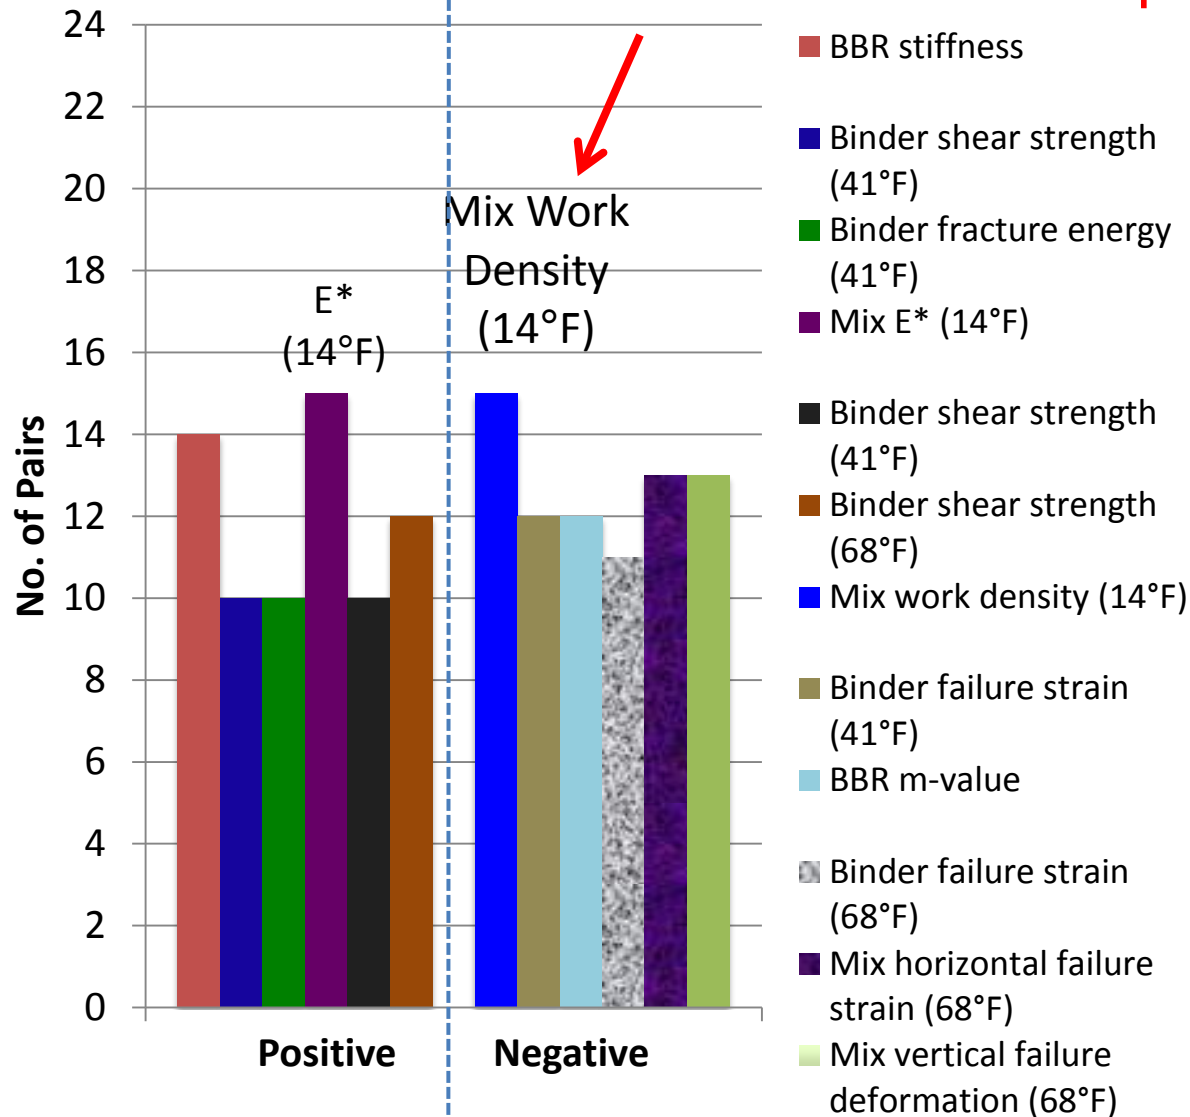
# Significant Determinants for Transverse Cracking Based on 1<sup>st</sup> Round Results

15 out of 21 HMA/WMA pairs

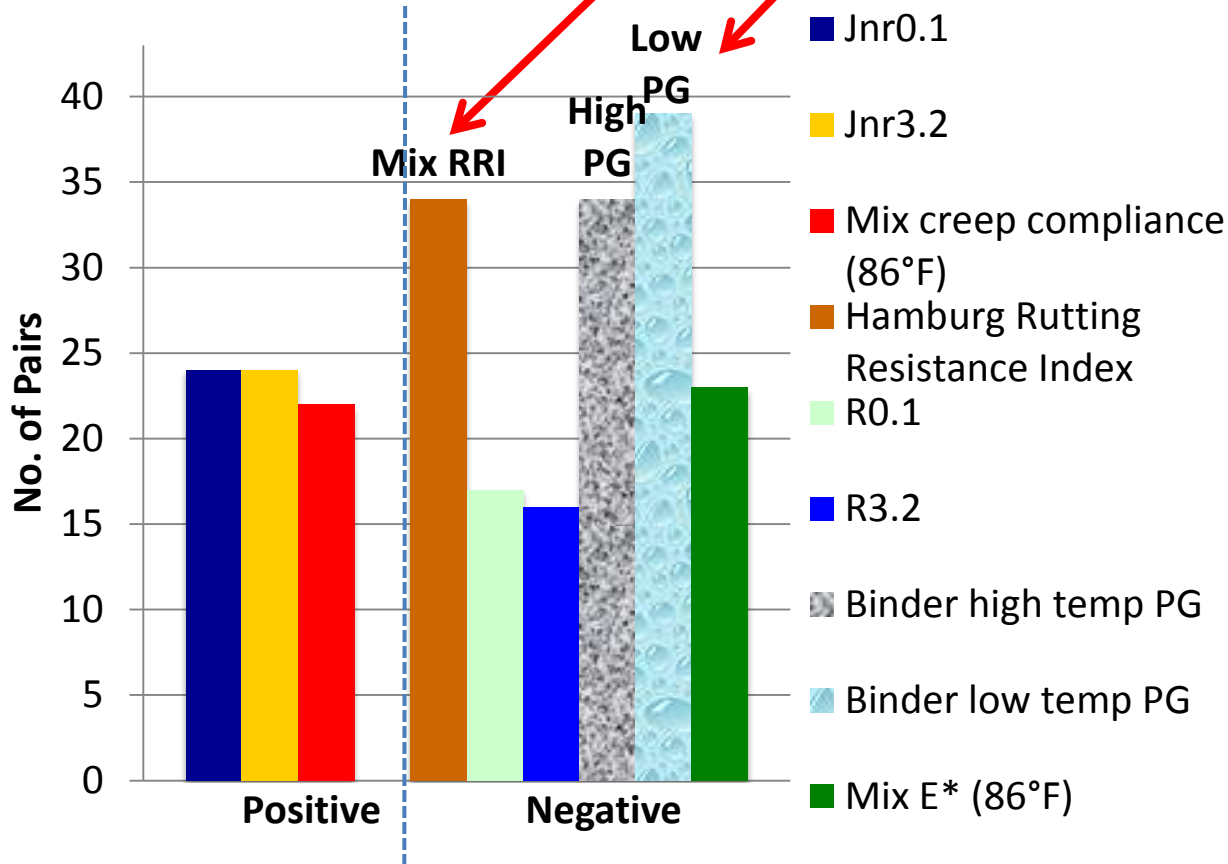
# Significant Determinants for Rutting Resistance

34 out of 41 HMA/WMA pairs

39 out of 43 HMA/WMA pairs

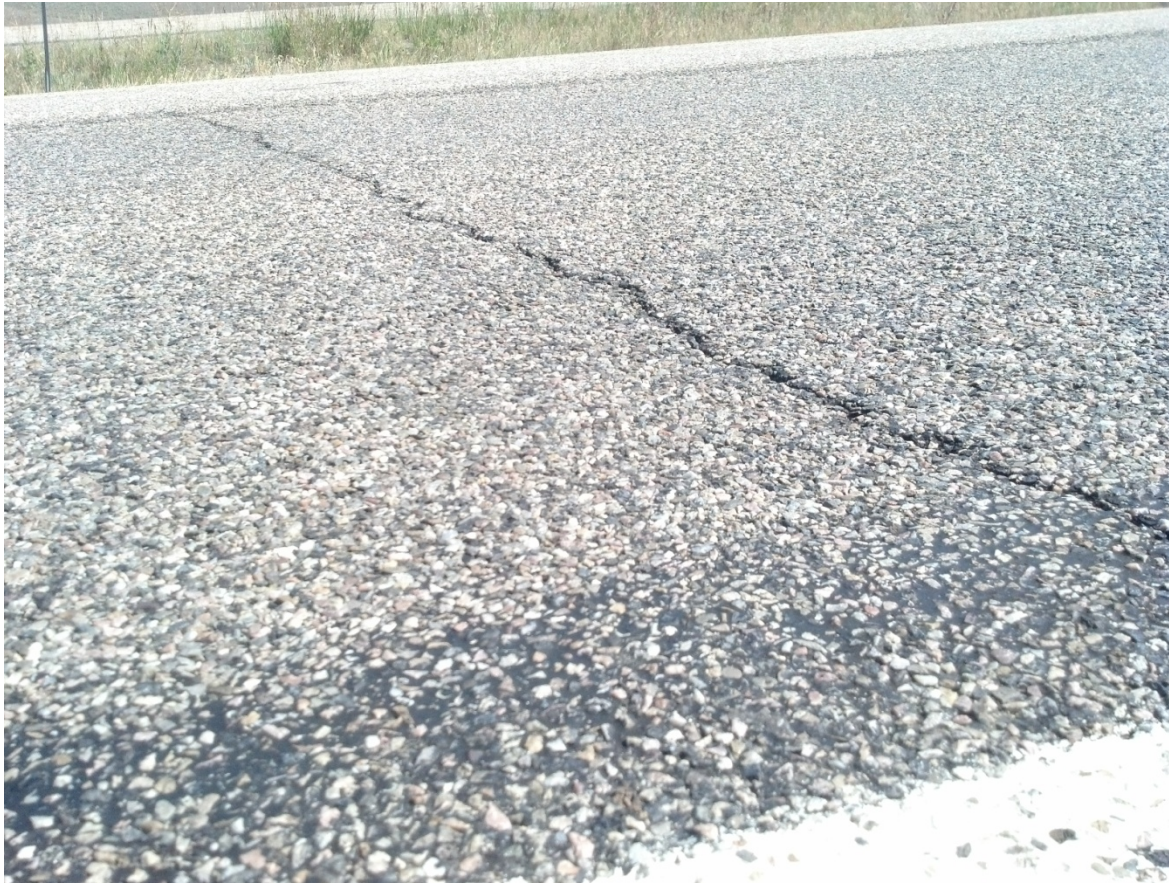
# MT I-15 Project: Chip Seal On the Surface

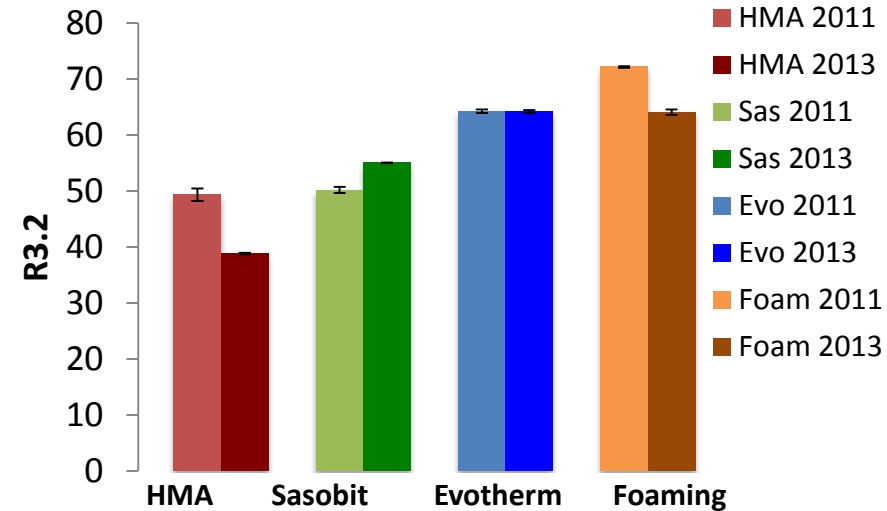
# MT I-15 Project: 2013 Vs 2011 Field Cores

## Binder MSCR Tests

2013 vs 2011	HMA	Sasobit	Evotherm	Foaming
d2s, Jnr3.2 (31.3%)*	18.4% (=)	55.8% (<)	14.5% (=)	26.6% (=)
d2s, R3.2 (17.3%)*	23.8% (>)	9.2% (=)	0.12% (=)	11.8% (=)

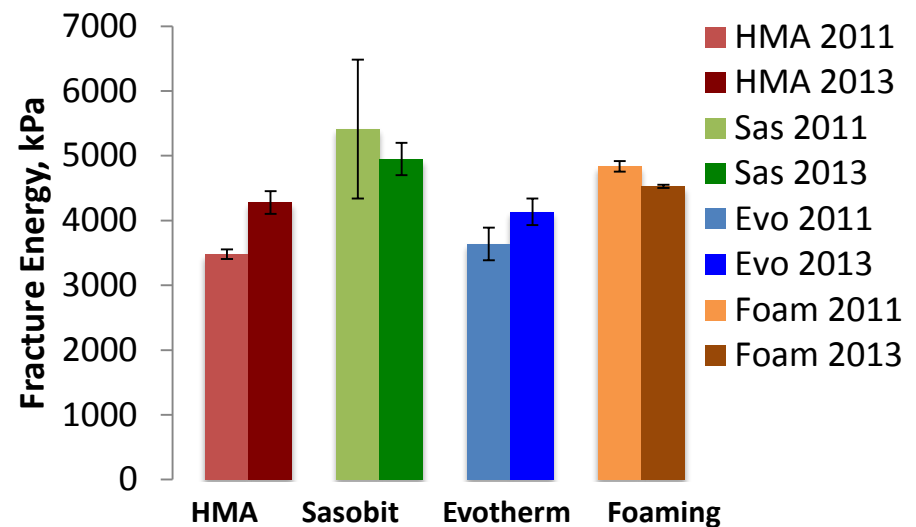
# MT I-15 Project: 2013 Vs 2011 Field Cores

## Binder Fracture Tests at Intermediate Temperature

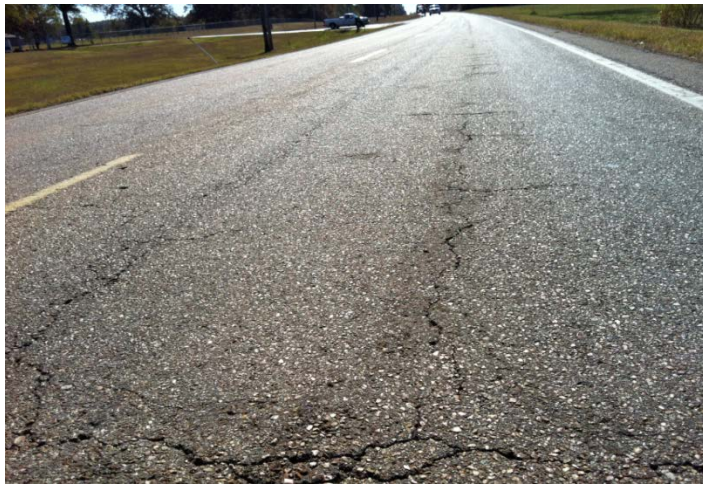
Before Construction

# TN SR 125 Project: HMA Pavement

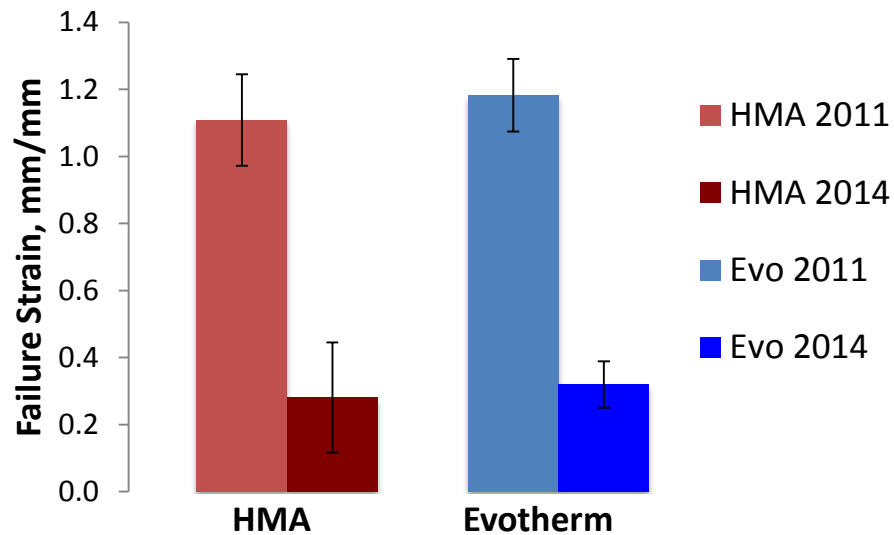
# TN SR 125 Project: 2014 Vs 2011 Field Cores

## Binder Fracture Tests at Low Temperature

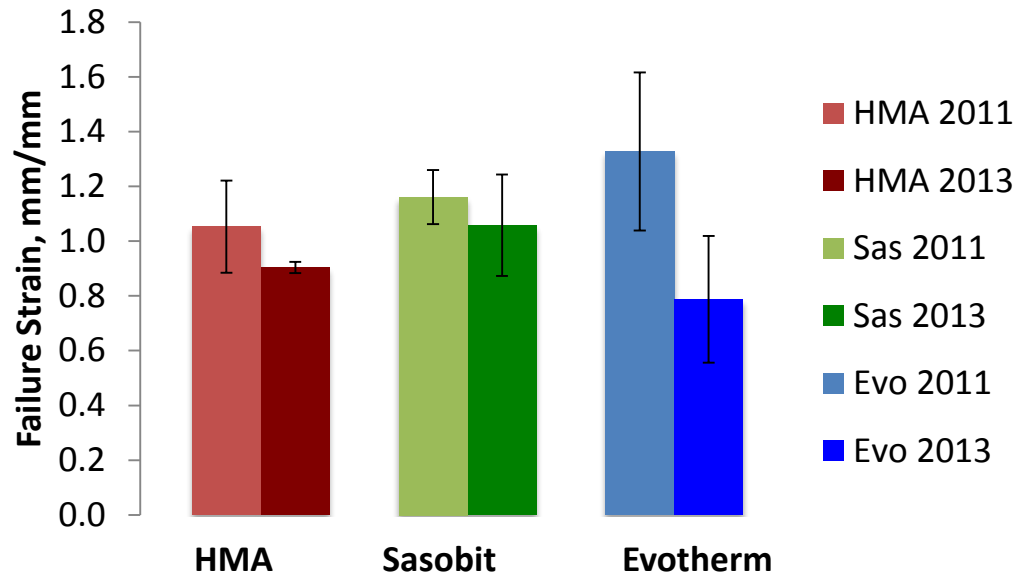
# IA US 34 Project: 2014 Vs 2011 Field Cores

## Binder Fracture Tests at Low Temperature

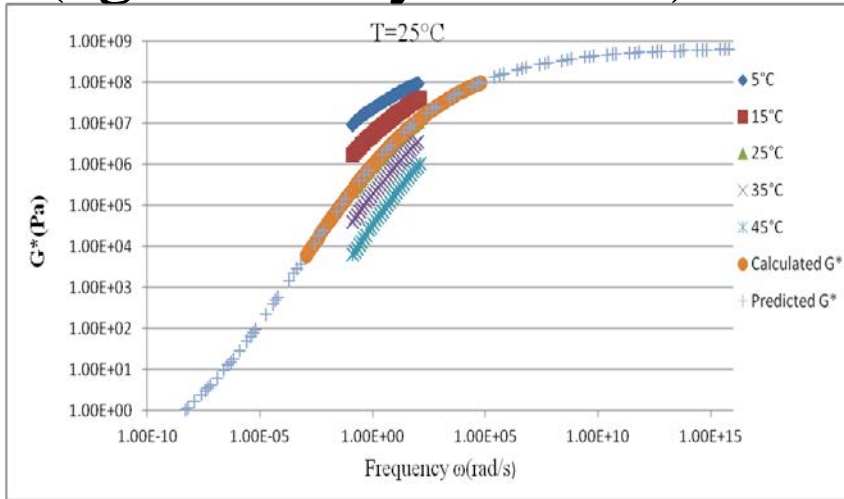
# Predicted master curve of $G^*$ and $\delta$ (CA model) (aged 40 days at 70C)
