NCHRP 9-49A Project Performance of WMA Technologies: Stage II – Long-term Field Performance

**Oklahoma City, OK
September 17, 2015**

Research Objectives

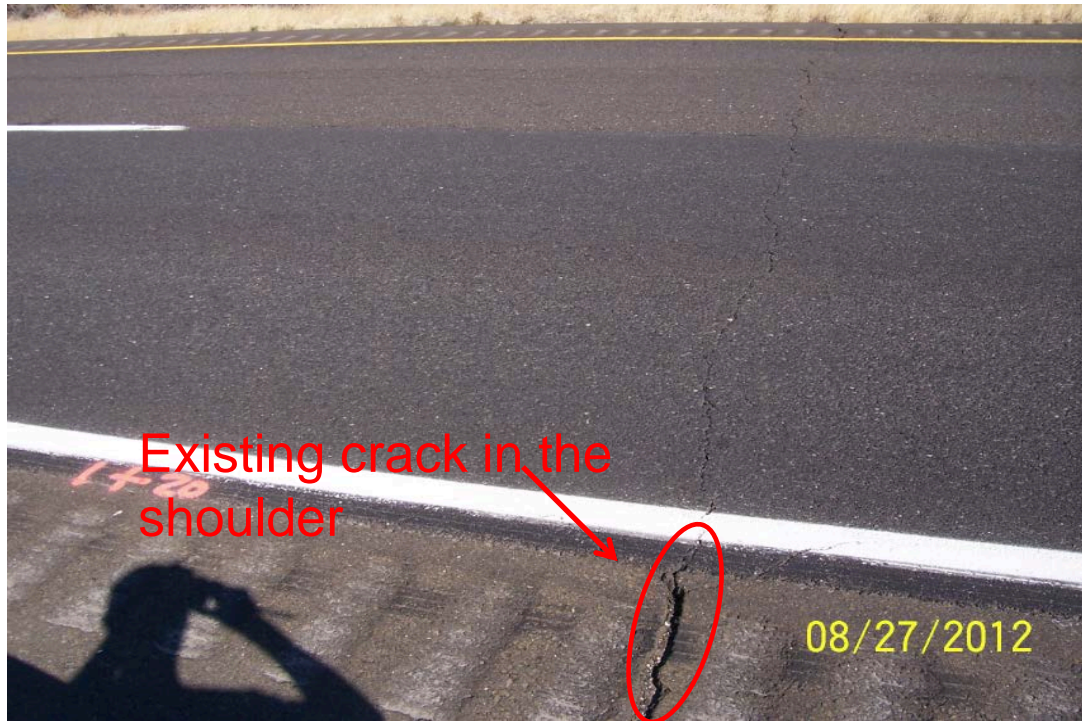
Transverse Cracking

Reflective

Surface-initiated

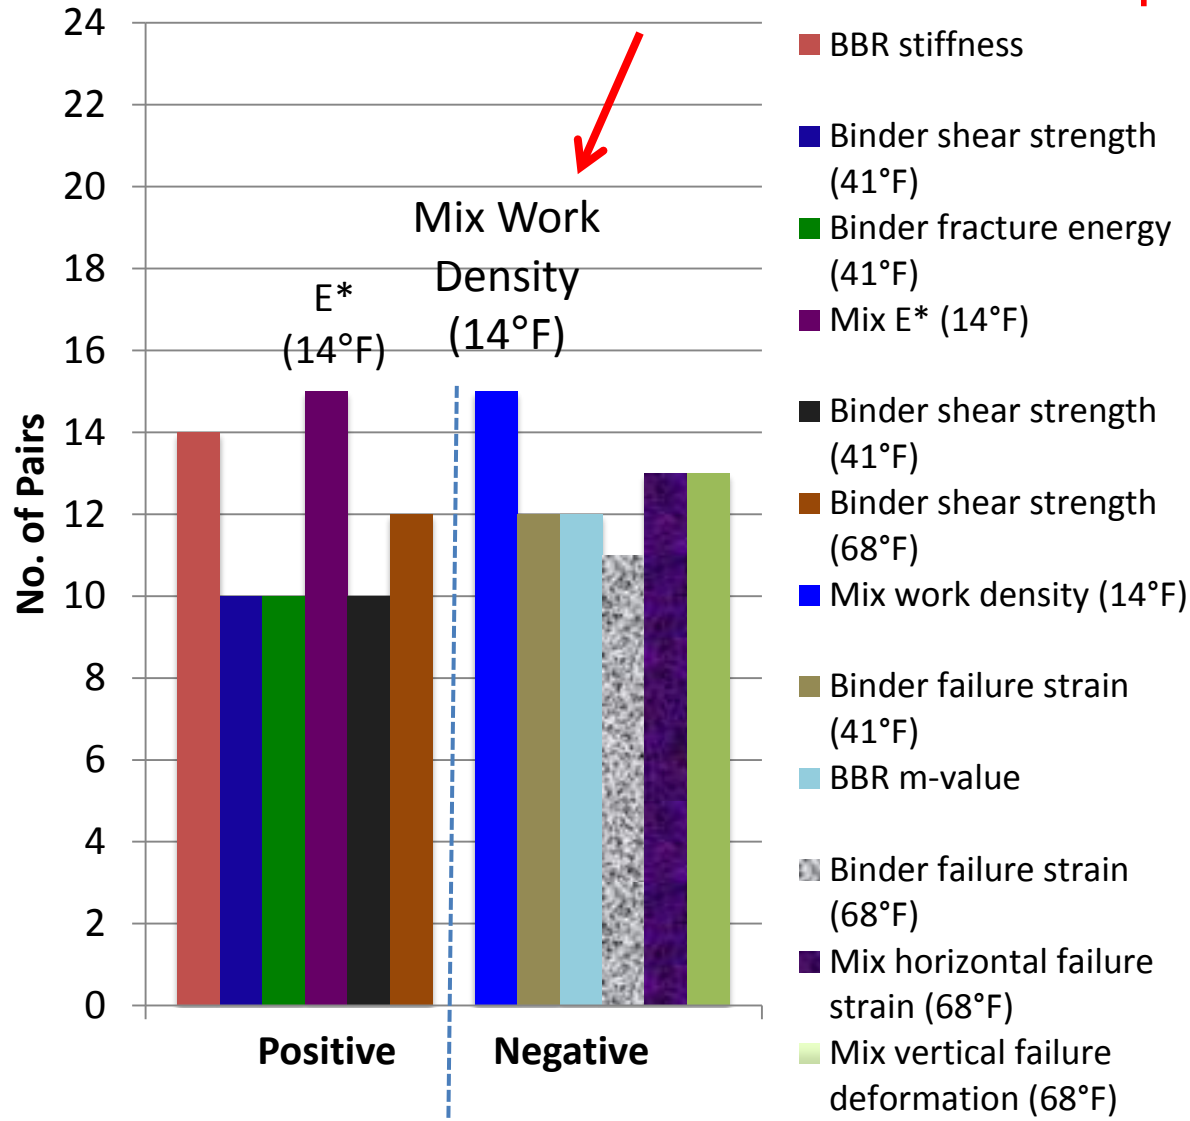
Significant Determinants for Transverse Cracking Based on 1st Round Results

15 out of 21 HMA/WMA pairs

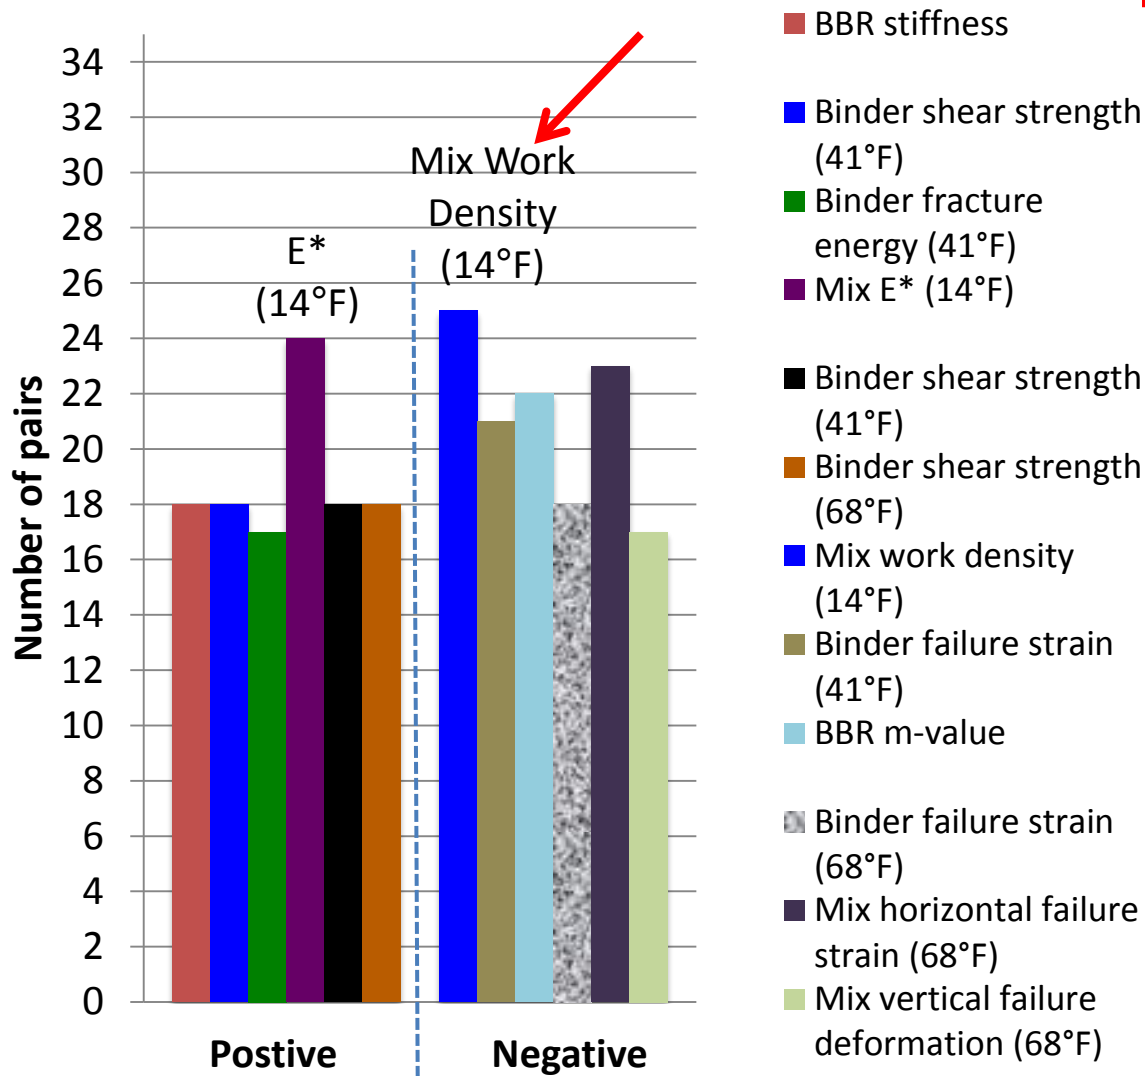
Verification: Significant Determinants for Transverse Cracking Based on 2nd Round Results

25 out of 35 HMA/WMA pairs

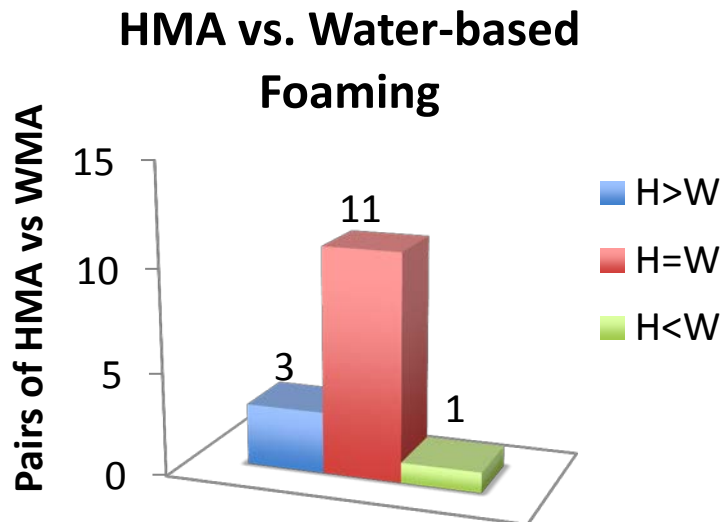
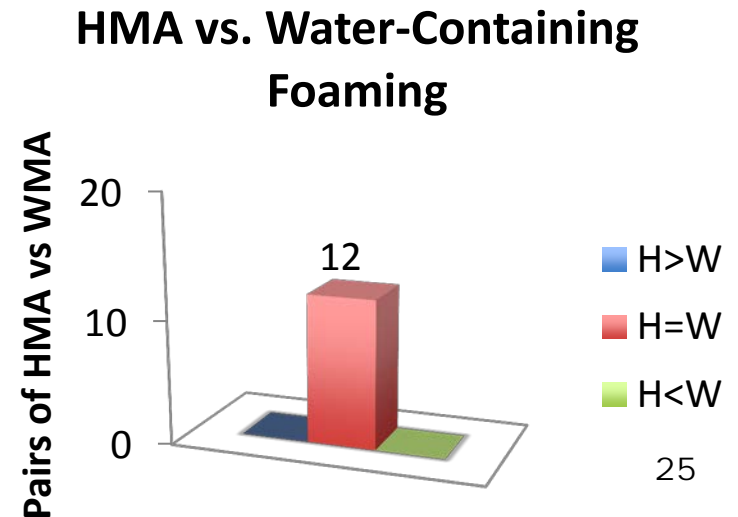
Use of Fracture Work Density as Indicator for Transverse Cracking Performance

HMA and WMA are comparable.

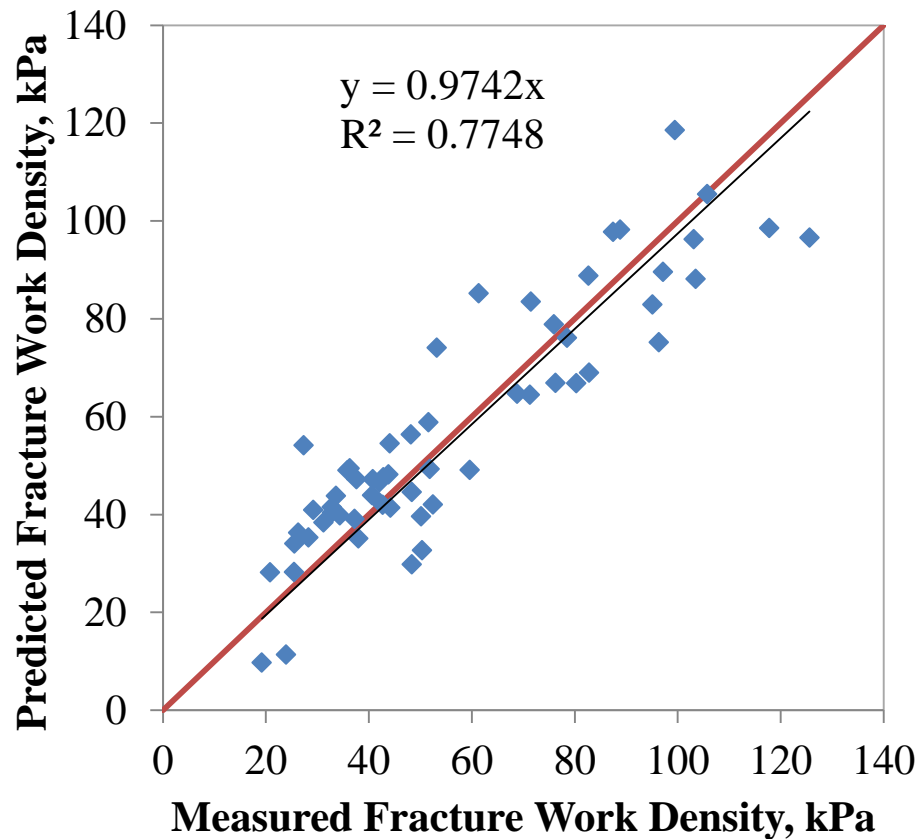
Measured Work Density Vs Calculated Work Density

$$\text{FWD} = -91.38 + 0.387\text{VFA} + 66.74G_{se} + 8.08\varepsilon_b + 15.76P_b + 2.97P_{50}$$

Parameter	Description	P-value
FWD	= mixture fracture work density tested at 14°F, kPa	
G_{se}	= aggregate effective specific gravity	0.006
VFA	= voids filled with asphalt, %	0.006
ε_b	= binder failure strain tested at 41°F	0.000
P_b	= asphalt content, %	0.000
P_{50}	= percentage passing No. 50 sieve size	0.000

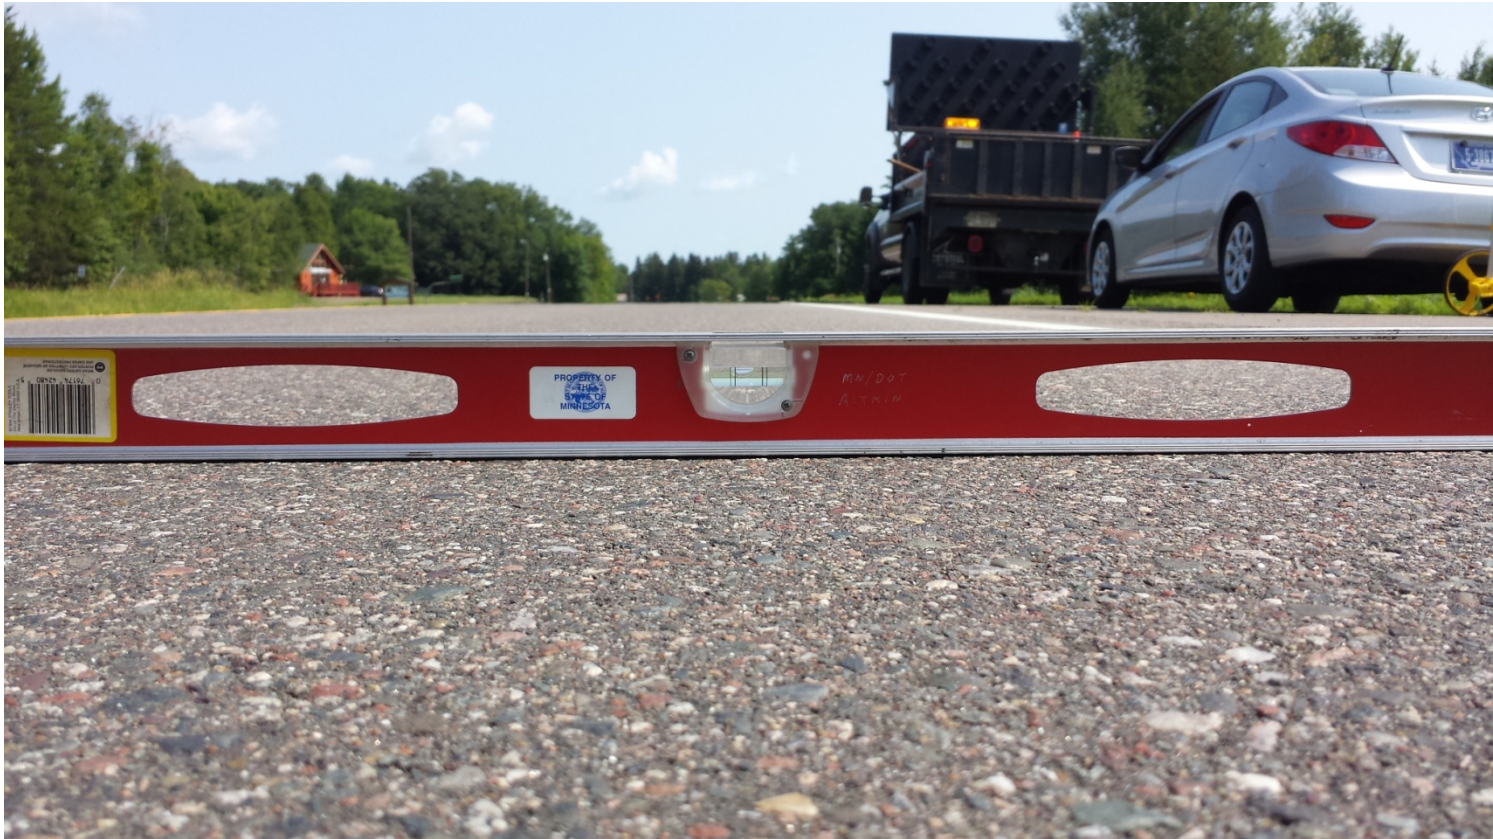
2nd Round HMA/WMA Rutting Performance Comparison

23 projects (43 H-W pairs) exhibited measurable rut depth.
