# Cracking Group Experiment – Evaluation of Laboratory Cracking Tests

**FHWA Mixture ETG – May 2018**

# Cracking Group Experiment

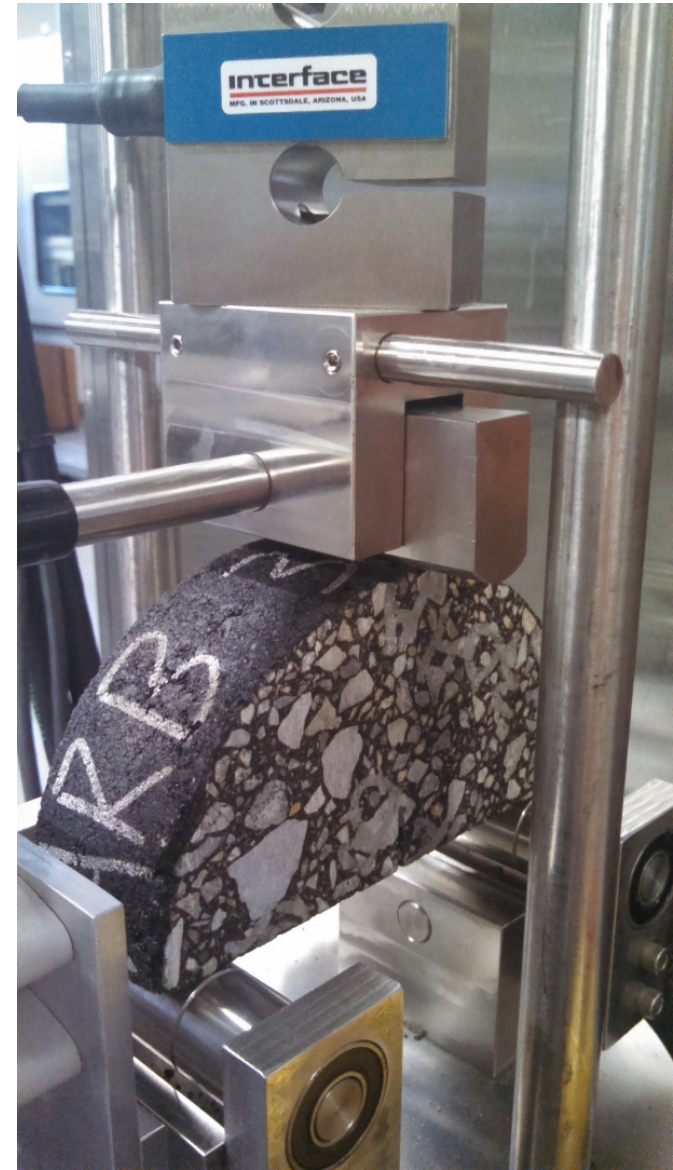
# Illinois Flexibility Index Test (I-FIT)

- 25°C
- 50 mm/min load rate
- Minimum 4 replicates
- 50 mm wide specimens
- Notch Depth = 15 mm
- Notch Width = 1.5 mm
- Load vs. Axial Deformation
- Test until load drops below 0.1 kN
  - ▷ Complete Fracture

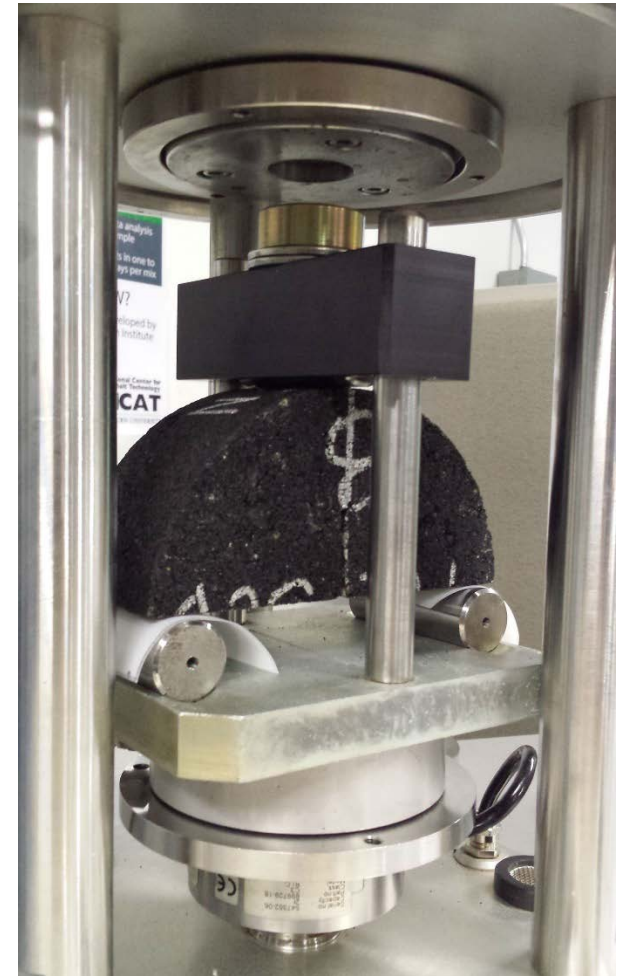
# Semi-Circular Bend – J<sub>c</sub> Method

- 25°C
- 0.5 mm/min load rate
- 57 mm wide specimens
- 12 replicates
- 3 notch depths
  - ▷ 25.4 mm
  - ▷ 31.8 mm
  - ▷ 38.1 mm
- 3.0 ± 0.5 mm notch width
